PF Olsen Toolbox Safety Alert 94

Date: October 2025	Focus Group: PCBUs and Drivers
Topic: Truck Slide – Near Catastrophe	Issued by: Nic Steens

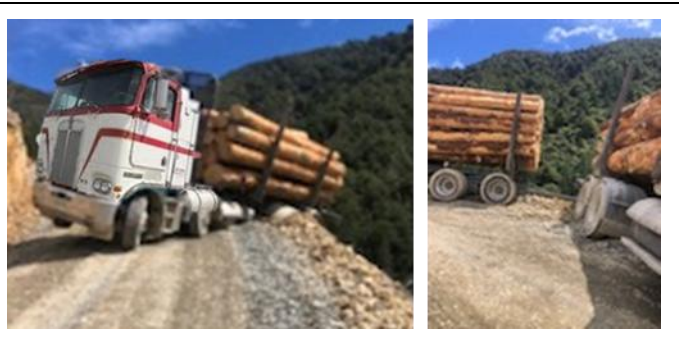
Background: On 7 October, a loaded log truck slid on a steep section of road after overnight and early-morning rain. The trailer slid and pushed the rear truck wheels over the edge of the road formation, coming to rest in the soft fill on the road edge — avoiding what could have been a serious down-hill rollover. The driver exited safely. The truck and trailer were unloaded, stabilised, and recovered. Operations were paused, the area checked, and cartage safely resumed the following day.

Injury and Damage: The trailer sustained minor wiring and tyre damage.

- **Peer review of roads** that approach the [NZFOA Forest Road Engineering Manual](#) design limits is a valuable safety check before and during cartage operations.
- **Suspend cartage** when rain or road conditions increase risk, and resume only after inspection and PCBU approval.
